# Abandon Aquaculture Remediation Along the West Coast of Vancouver Island

**COASTAL  
RESTORATION  
SOCIETY**

Funding Through: DFO's 2021-22 Sustainable Fisheries Solutions and Retrieval Support Contributions Program

# Abandoned Aquaculture Infrastructure

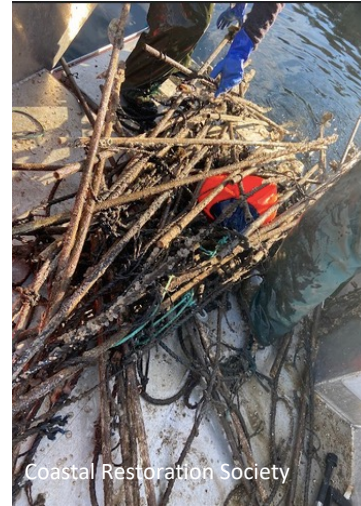
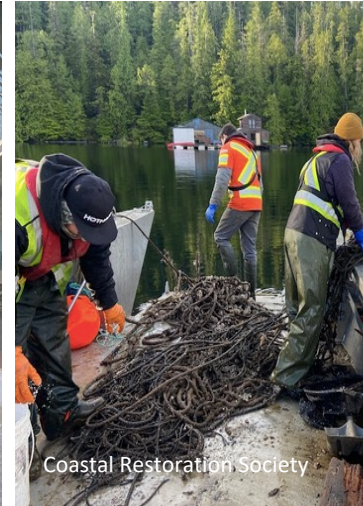
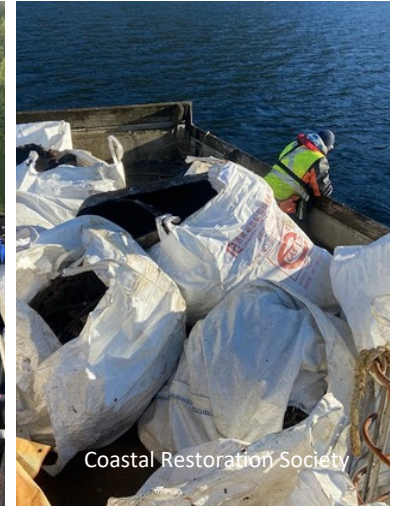
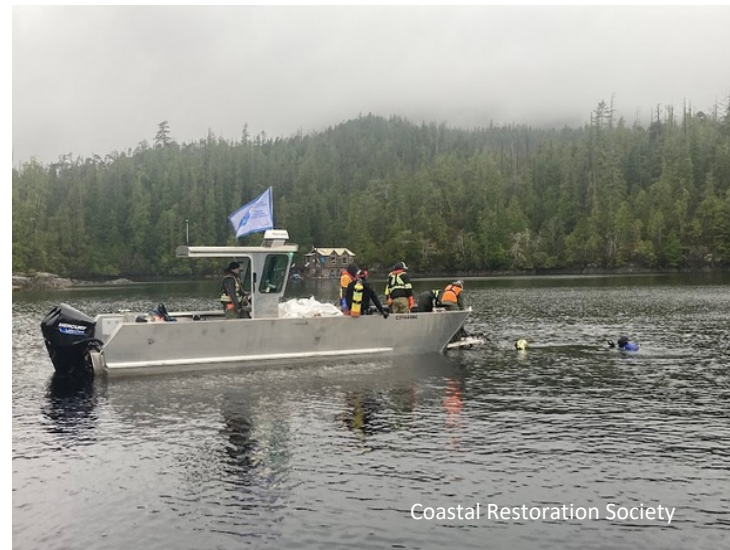
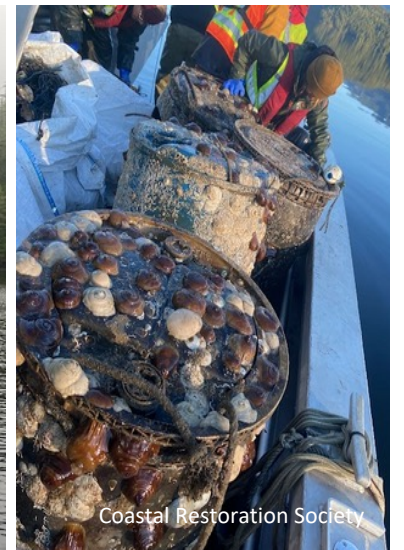
# Tla-o-qui-aht FCS Territory

- Shellfish Aquaculture site
- Opitsaht, Clayoquot Sound
- Shallow Water Suspended System
- Subsurface Removal- CRS Dive Team

- ~ 6600 ft of oyster seed lines
  - ~29,000 ft Rope Removed
  - Large volumes of non-ALDFG debris
- ~22,000 kgs of total ALDFG Removed

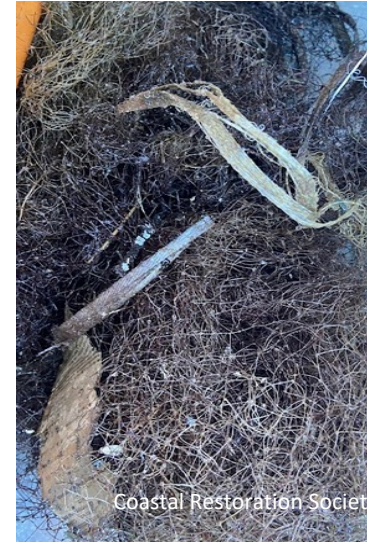
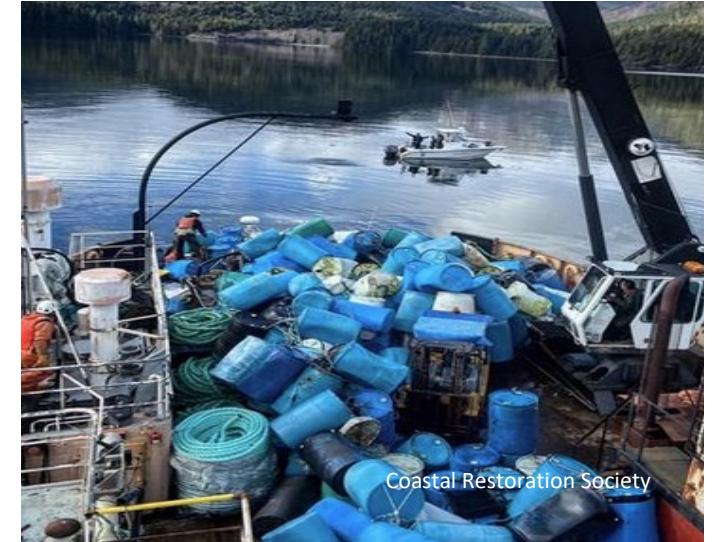
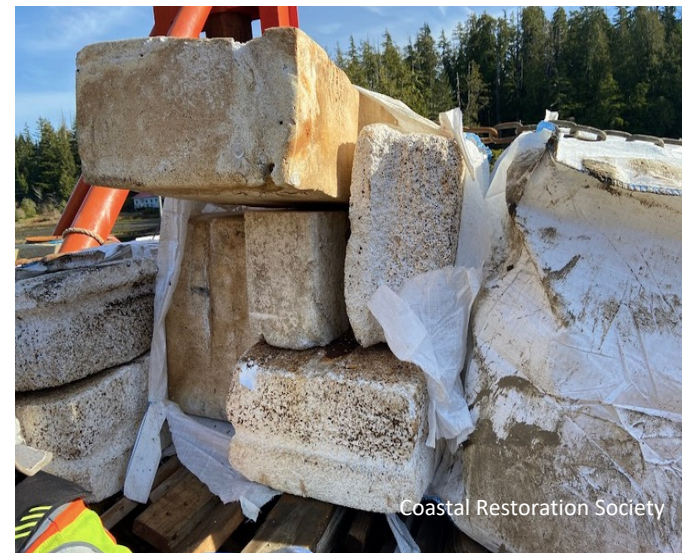
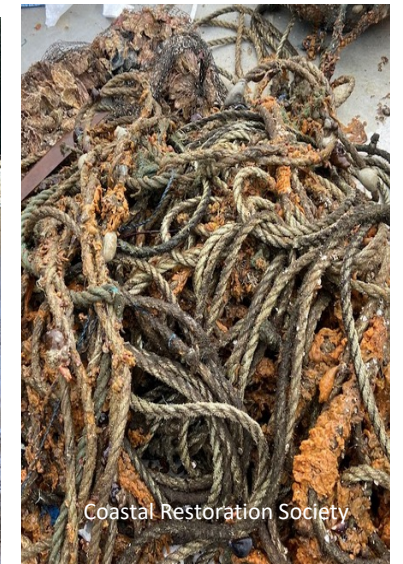
# Huu-ay-aht FCS Territory

- Finfish Aquaculture Site
- Bamfield Inlet, Barkley Sound
- Bivalve Aquaculture
- Hydro Fluorocarbons illegally stored and disposed
- SARA

- ~1200 Cubic Feet Of Polystyrene
- 95- 55 Gallon Barrels. 12 With Hazardous Waste
- ~3000 Ft Ropes, Nets, And Cables
- Primarily Structural Wood Debris

~108, 000 Kg of Total ALDFG Removed

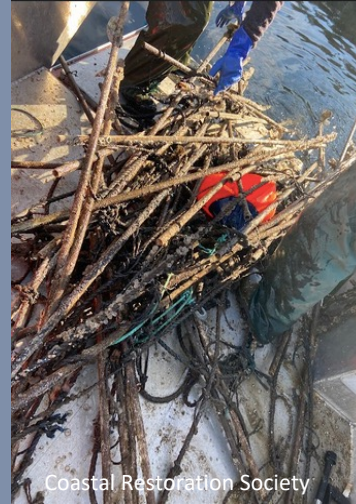
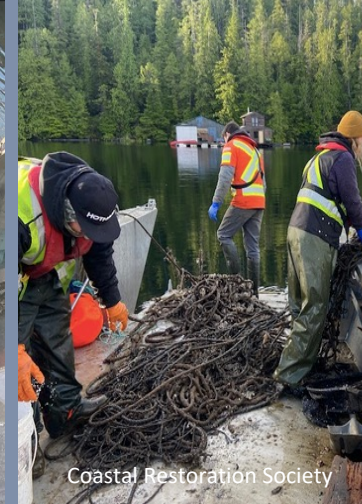
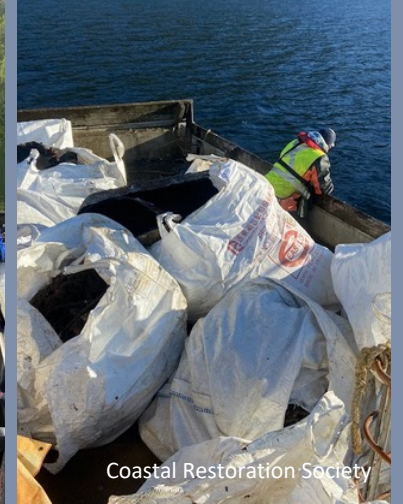
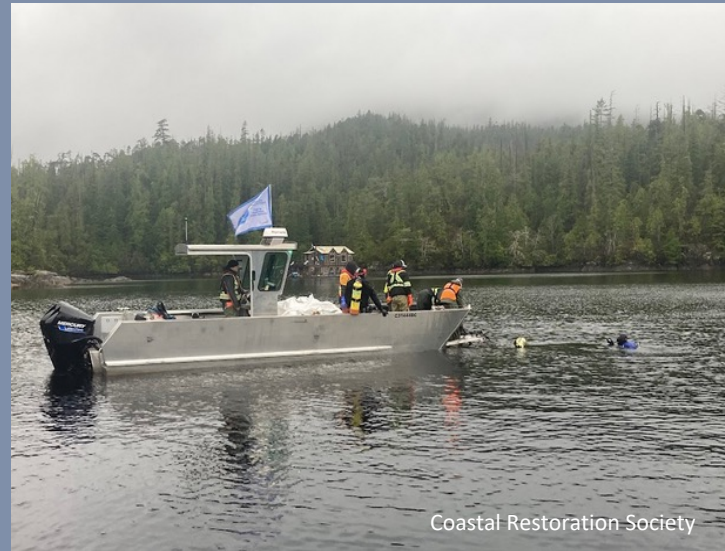
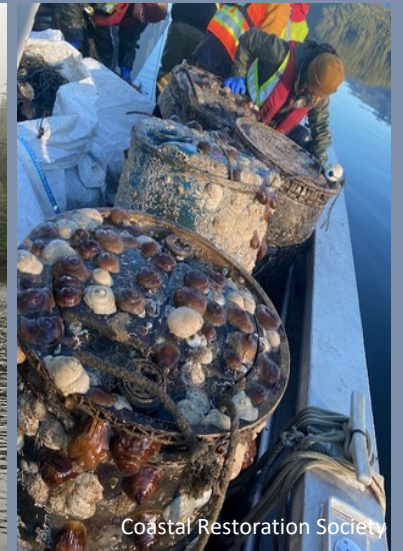
# Tla-o-qui-aht FCS Territory

- Shellfish Aquaculture site
- Opitsaht, Clayoquot Sound
- Shallow Water Suspended System
- Subsurface Debris Removal- CRS Dive Team

- ~ 6600 ft of oyster seed lines
- ~29,000 ft Rope Removed
- Large volumes of non-ALDFG debris

~22,000 kgs of total ALDFG Removed

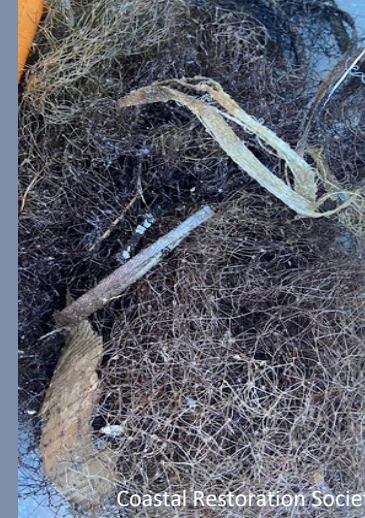
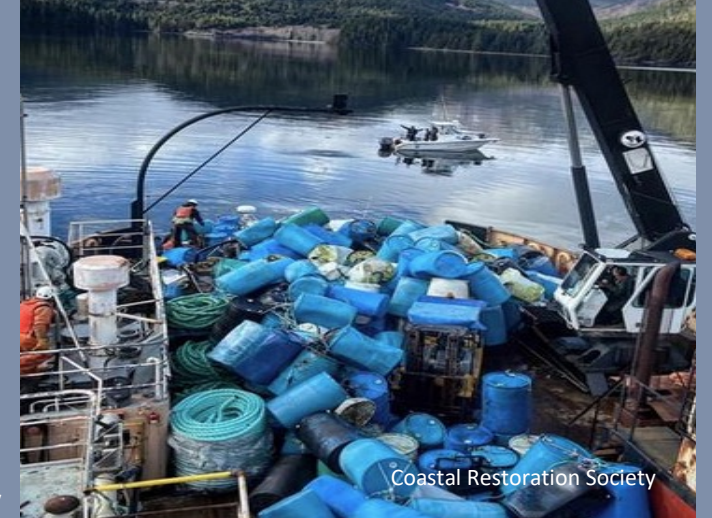
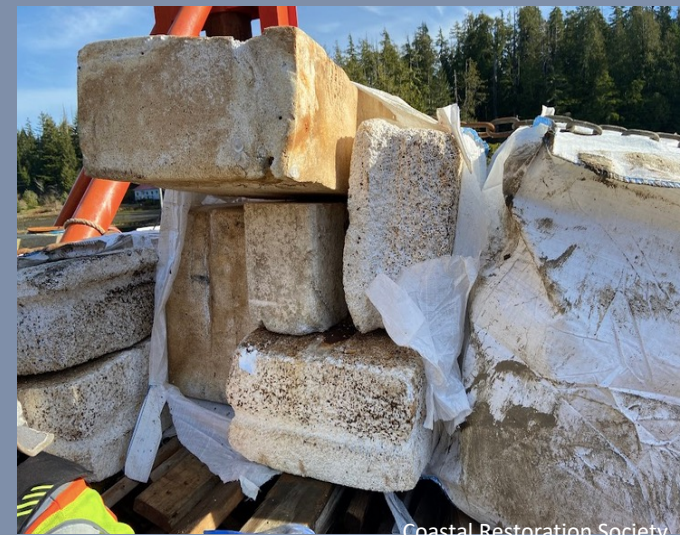
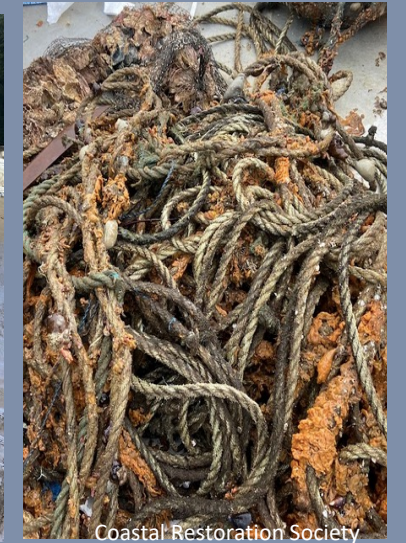
# Huu-ay-aht FCS Territory

- Finfish Aquaculture Site
- Jane Bay, Barkley Sound
- Open-water
- SARA- Surface Removal Only CRS Field

- ~1200 Cubic Feet Of Polystyrene
- 95- 55 Gallon Barrels. 12 With Hazardous Waste
- ~3000 Ft Ropes, Nets, And Cables
- Primarily Structural Wood Debris

~108, 000 Kg Of Total ALDFG Removed
